# Agricultural Water Conservation Demonstration Initiative

Harlingen Irrigation District

# 2008

The Harlingen Irrigation District-Cameron County No. 1, under the auspices of a grant from the Texas Water Development Board, is sponsoring the Agricultural Water Conservation Demonstration Initiative (ADI), a multi-year project to conduct a study of the maximization of on-farm surface water use efficiency by integration of on-farm application and district delivery systems. This document contains the third annual progress report to the Texas Water Development Board.

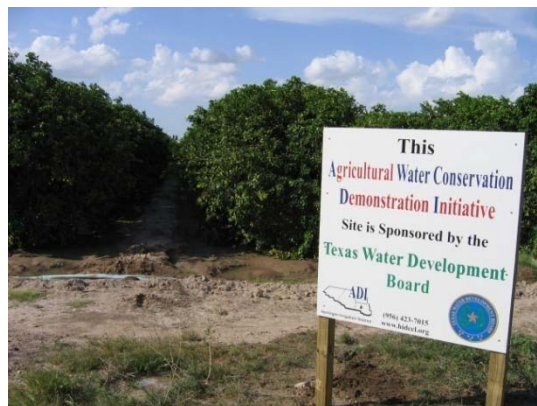
Acres: 50  
Soil type: clay loam 0-6 inches, sandy clay loam 6-36 inches  
Field characteristics: 15' x 24' spacing (115 trees/Acre)  
Crop variety: Rio Red grapefruit  
Harvest season: Feb 08-Mar 09  
Irrigation district: None-Class B water owner  
Irrigation system: Narrow bordered flood, polypipe

Soil moisture: Decagon data logger EM-50, ECHO-10 probes, Probes set at 6", 12", and 24" depths; and 10 inch Turbine-type flow meter.

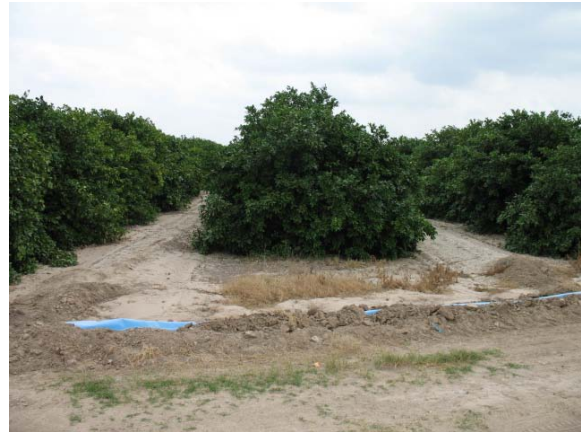
Acres: 85.0  
Soil type: clay loam 0-18 inches,  
loam 18-36 inches  
Crop variety: Rio Red grapefruit  
Harvest season: Feb 08-Mar 09  
Field characteristics: 15' x 24' spacing  
(115 trees/Acre)  
Irrigation district: None-Class B water  
owner  
Irrigation system: Narrow bordered flood, polypipe

Soil moisture: Decagon data logger EM-50, ECHO-10 probes, Probes set at 6", 12", and 24" depths; and Davis Instruments Rain gauge located on adjacent Site #01C. Watchdog datalogger and Watermark sensors placed at same depths. Turbine-type flow meter

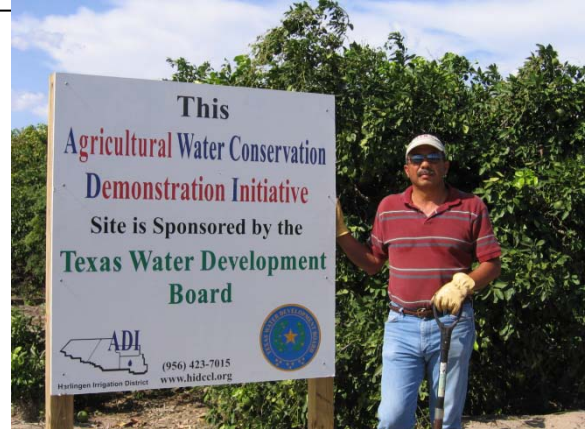
Acres: 8.0  
Soil characteristics: sandy clay loam 0-36"  
Crop variety: Rio Red grapefruit  
Irrigation district: United  
Field characteristics: 15' x 24' spacing (115 trees/Acre)  
Irrigation system: Microjet spray

Decagon data logger EM-50, ECHO-10 probes, Probes set at 6, 12, 24 and 36 inch depths; Watchdog Data logger and 6", 12" and 24" watermark soil moisture sensors, Davis Instruments Rain gauge.

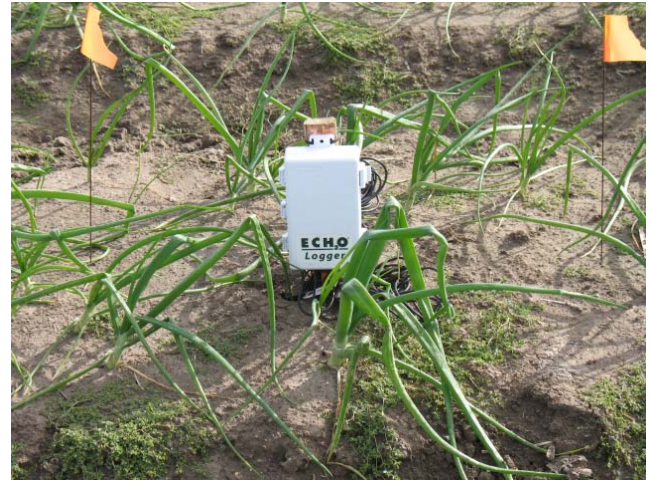
Acres: 22.0  
Soil characteristics: Clay  
Crop variety: White Onion  
Irrigation district: Delta Lake  
Irrigation system: Sub-surface drip  
Field characteristics: Onions planted early Oct '08, and harvested mid Mar '09;  
60 inch beds, 18" emitter spacing with 6 onion lines per bed, rows spaced 7 inches apart.

Irrrometer data logger with Watermark sensors; sensors set at depths 6-, 12-, and 24-inch bed center, and 6- and 12-inches at edge of bed.

Drip tape buried center of bed, 4 to 6 inches deep, 7/8 inch tape at low flow rate of 0.24 gph. Irrigation scheduling was not based on soil moisture monitoring but by grower experience. Irrigated using a portable sand filter/ pump combination and metered each time.

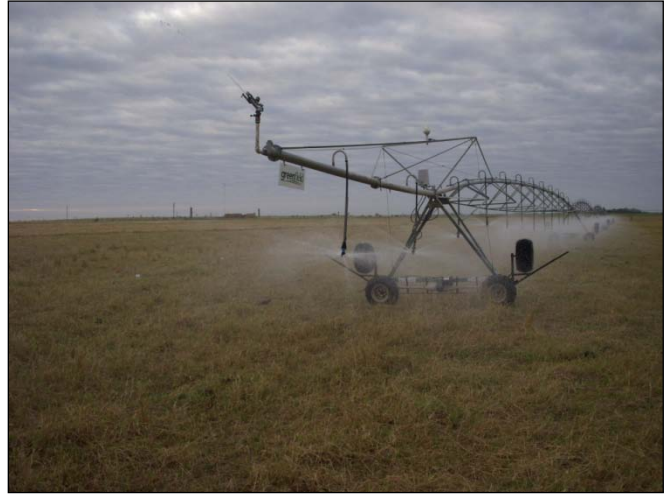
625-foot center pivot (MESA) with  
62 rotating spray applicators and a  
terminal gun  
Fertilization: 250 lbs/acre of Nitrogen

Watermark (6, 12 & 24-inch depth connected to 1 data logger. Water meter located at the pump.

Soil moisture levels averaged at 74cb for 6-inch profile, 98cb for 12-inch profile, and 50cb for 24-inch profile

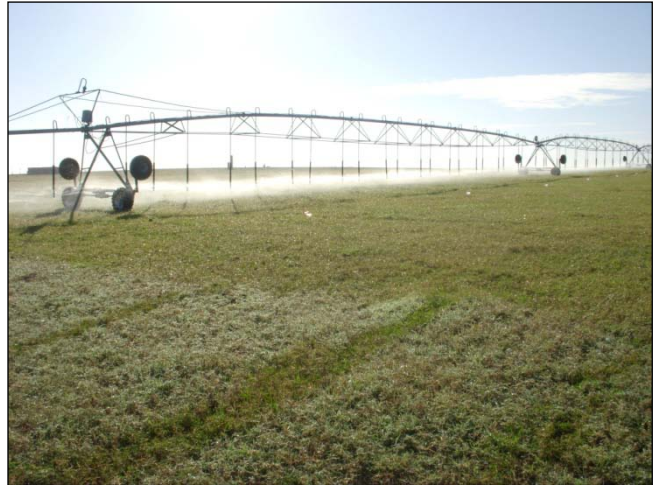
642-foot center pivot (MESA) with  
126 spray applicators; no terminal  
gun  
Fertilization: 250 lbs/acre of Nitrogen

Watermark (6, 12 & 24-inch depth connected to 1 data logger. Water meter located at the pump.

Soil moisture levels averaged at 37cb for 6-inch profile, 24cb for 12-inch profile, and 19cb for 24-inch profile

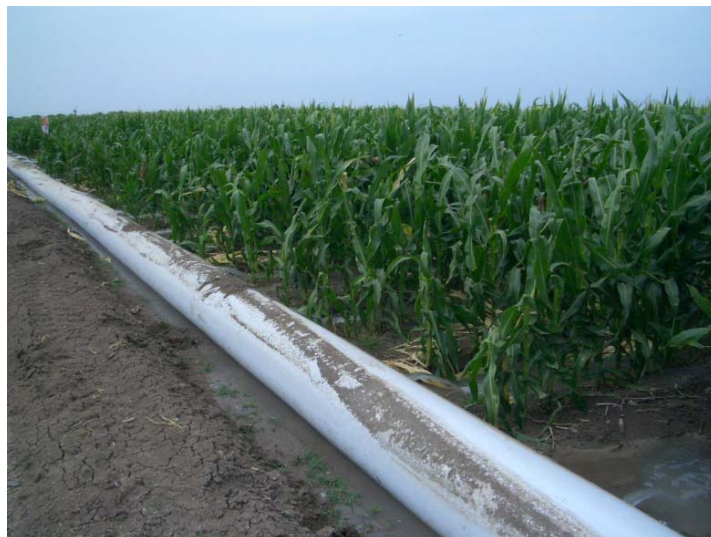
One furrow was selected in the center of the field with a sensor site 150' inside of the Southern turn row. Watermark soil moisture sensors were buried at a depth of 6", 12", and 24". A soil temperature probe was buried at a depth of 9". A Watermark monitor was used to continuously collect readings. The rain gauge at pump house 27 was used to collect the rainfall events.
