**Effect of Roof Material on Water Quality for Rainwater Harvesting Systems –
Progress Report to the Texas Water Development Board (TWDB)**

March 15, 2009

Texas Water Development Board

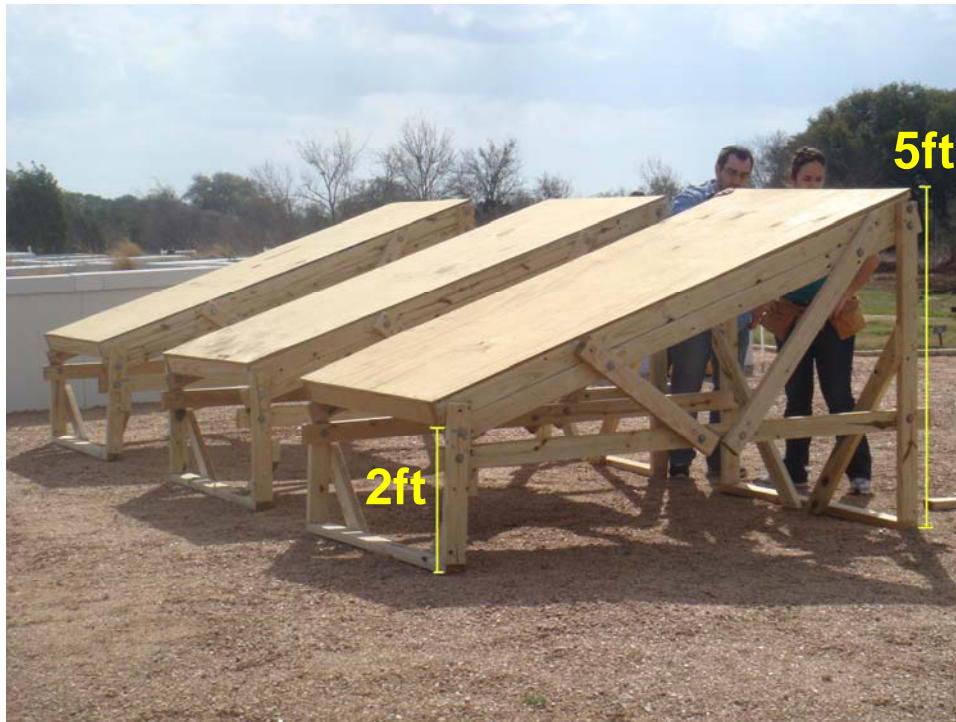
Figure 1. Frames for Pilot-Scale Roofs

Based on the results of Task 1, three roofing materials were selected for the test roofs to be installed at the Lady Bird Johnson Wildflower Center: GAF-Elk's asphalt fiberglass shingle, Berridge's Galvalume® standing seam metal, and MonierLifetile's concrete tile. Three wooden frames were constructed to hold a 4 ft by 8 ft plywood sheet that will support the roofing material. To simulate residential roofs, Austin contractors recommended that the pilot roofs have a pitch of 4:12 (Wilson Ralph, personal communication, 2009 and Harold Peterson, personal communication, 2009). As a result, the plywood boards were angled at 18.4 degrees. The frames are approximately 5-ft high with a 2-ft end for rainwater catchment (Figure 1).

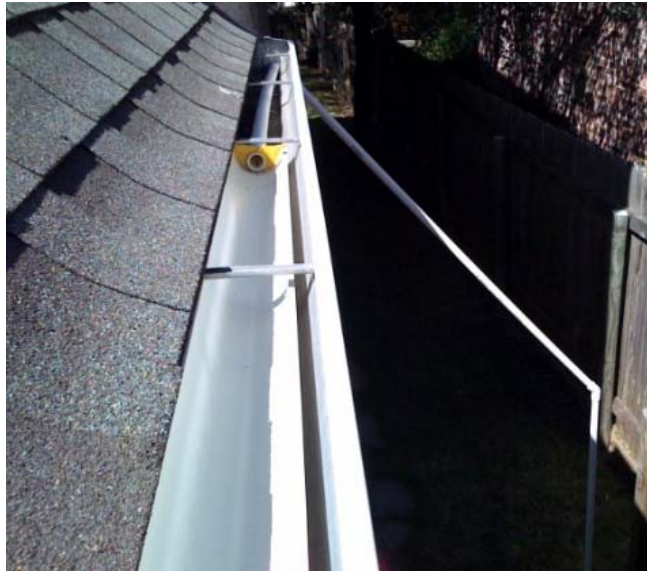
Figure 2. Sampler Gutter Insert

To collect the rainwater, the base of each roof was equipped with a simple sampling device that was inserted into the gutter (Figure 2). This insert consists of a clean 3-inch diameter PVC pipe (potable quality) cut lengthwise in half and fitted with end caps. Three-quarter-inch PVC pipe was used to direct rainwater collected from the sampling insert to a passive collection system (**Error! Reference source not found.**) that consists of a two-liter (L) tank to collect the “first flush” and two 10-L tanks in series to collect volume samples after the first flush.

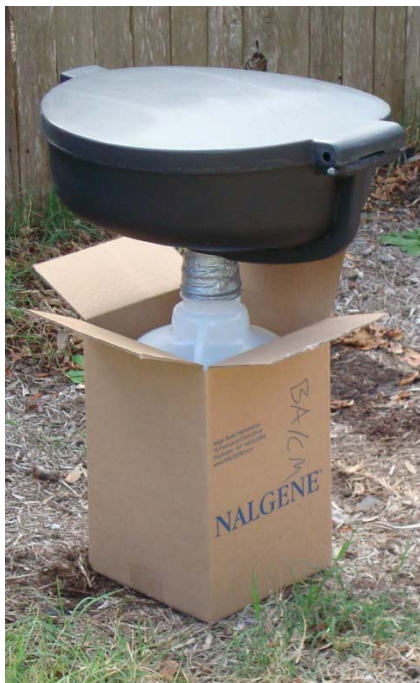
Figure 4. Ambient Sampler

In addition, each site was equipped with a separate sampler to collect ambient rainwater that does not come into contact with the roof. This sampler (Figure 4) consisted of an 18-inch diameter polyethylene funnel attached to a 10-L polypropylene collection container.

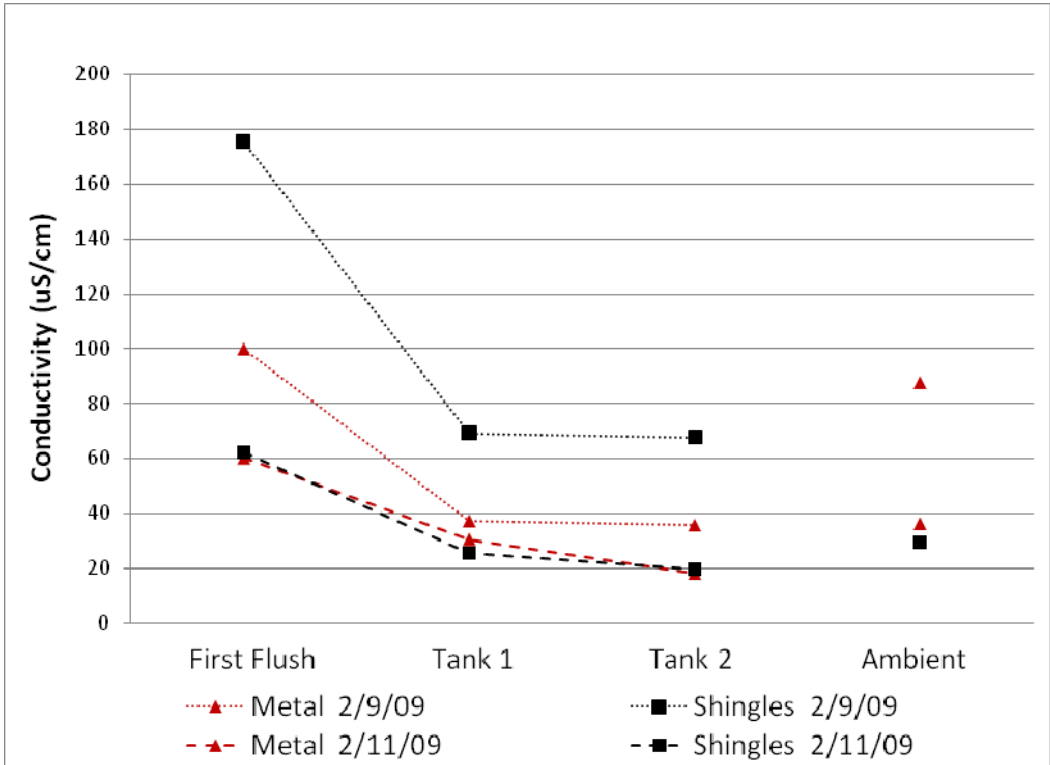
Figure 6. Conductivity of Harvested Rainwater from a Metal Roof and a Shingle Roof

Error! Reference source not found. presents the conductivity of the ambient and harvested rainwater from two events on the metal and shingle roofs. The conductivity decreased from the first flush through the first and second tanks, with final conductivities that were similar to those of ambient rain. Note that the conductivity of the first flush on the 2/11/09 rain event was lower

than that of the first flush on the 2/9/09 rain event. The conductivity values are within the same range found in the harvested rainwater studies of Yaziz et al. (1989) and Simmons et al. (2001).

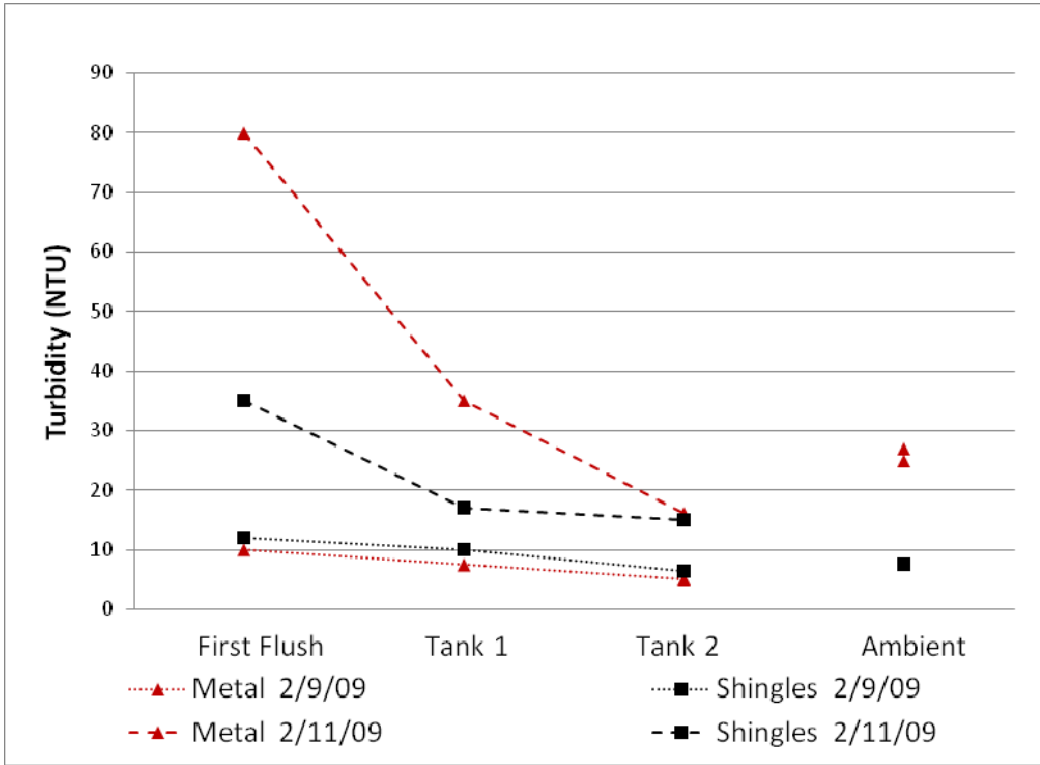
Figure 7. Turbidity of Harvested Rainwater from a Metal Roof and a Shingle

Figures 7 and 8 present the turbidity and total solids, respectively, of the ambient and harvested rainwater from two events on the metal and shingle roofs. The turbidity and total solids decreased from the first flush through the first and second tanks, with final values of turbidity and total solids that were close to those of ambient rain. The total solids values in the first flush of the metal roof were higher than the total solids values in the first flush of the shingle roof; this might be attributable to particle retention in the porous surface of the shingle roof as compared to the non-porous surface of the metal roof. The turbidity and total solids values are within the same ranges found in the harvested rainwater studies of Yaziz et al. (1989) and Simmons et al. (2001).

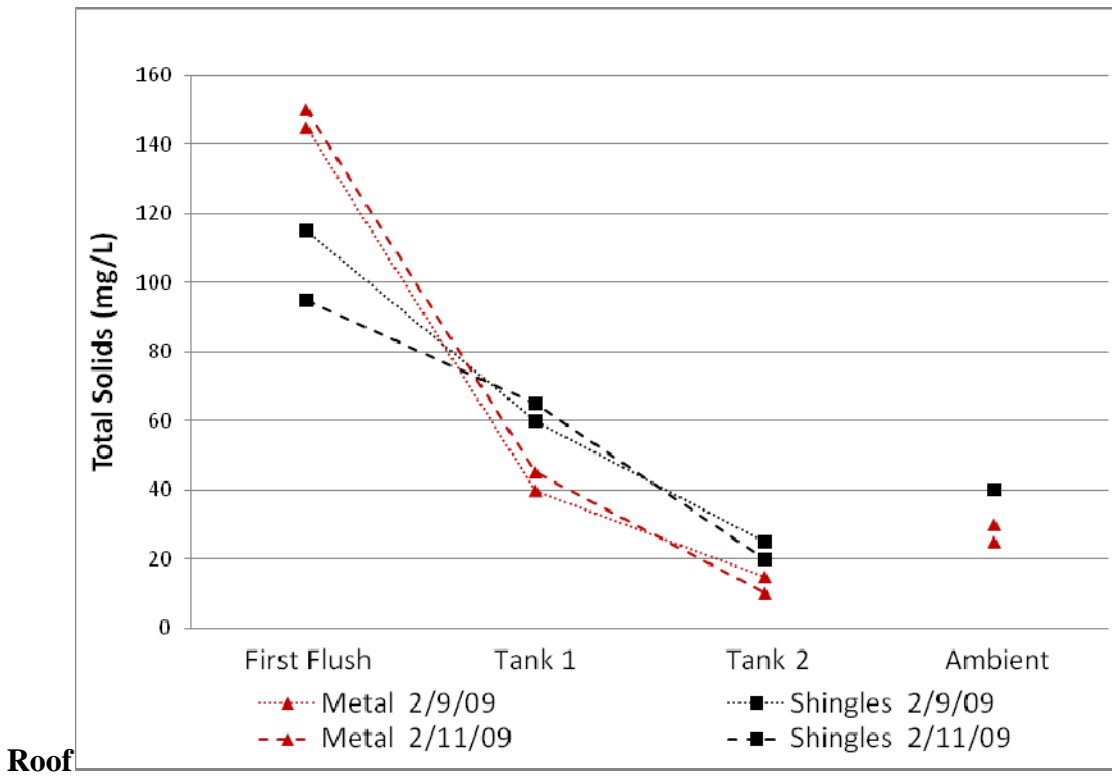
Figure 8. Total Solids of Harvested Rainwater from a Metal Roof and a Shingle Roof

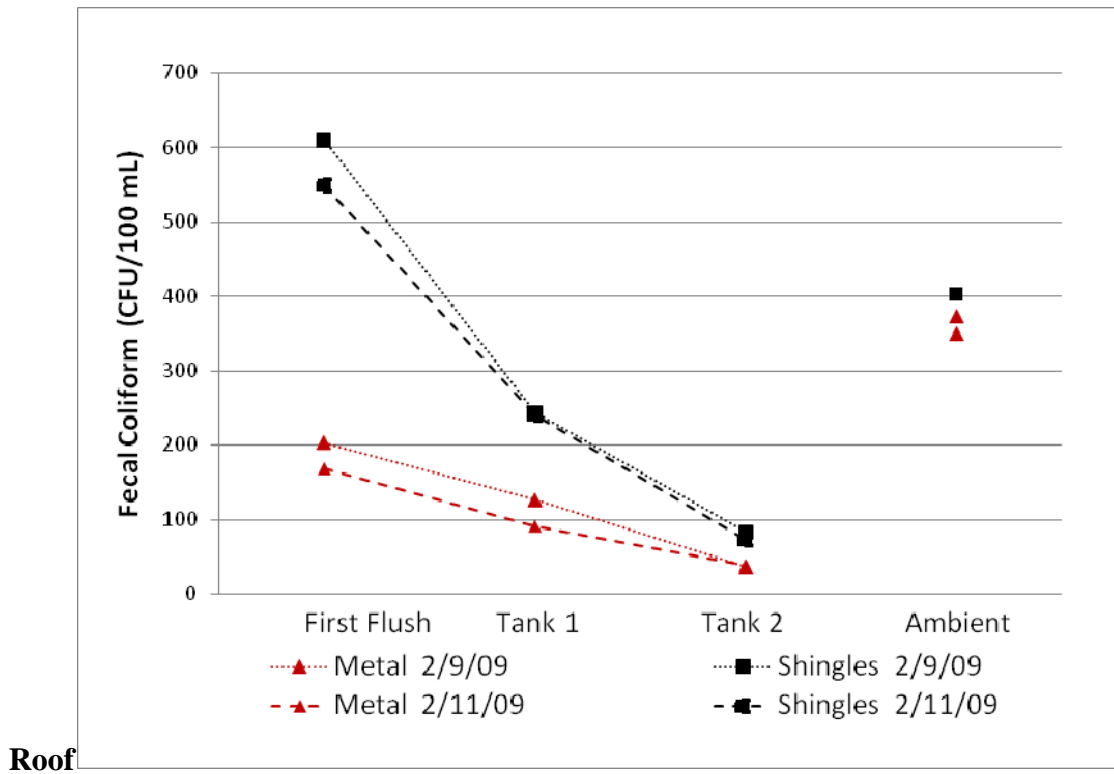
Figure 10. Fecal Coliform of Harvested Rainwater from a Metal Roof and a Shingle Roof

Figures 9 and 10 present the total coliform and fecal coliform counts, respectively, of the ambient and harvested rainwater from two events on the metal and shingle roofs. Each roof site had similar conditions with respect to tree cover to minimize differences in potential fecal contamination (e.g., by birds). The total and fecal coliform counts decreased from the first flush through the first and second tanks. However, even the second tank for both roofing materials always had detectable total and fecal coliform, indicating that treatment is needed prior to potable use. The total and fecal coliform counts were always higher in the rainwater harvested from the shingle roof than from the metal roof; to determine if this is truly due to roofing material differences, rather than site variation, a pilot-scale metal roof and shingle roof will be compared side-by-side at the Lady Bird Johnson Wildflower Center in Task 2.
