Figure 7  
 Geologic Strike Cross Section  
 of the Lower Glen Rose Limestone

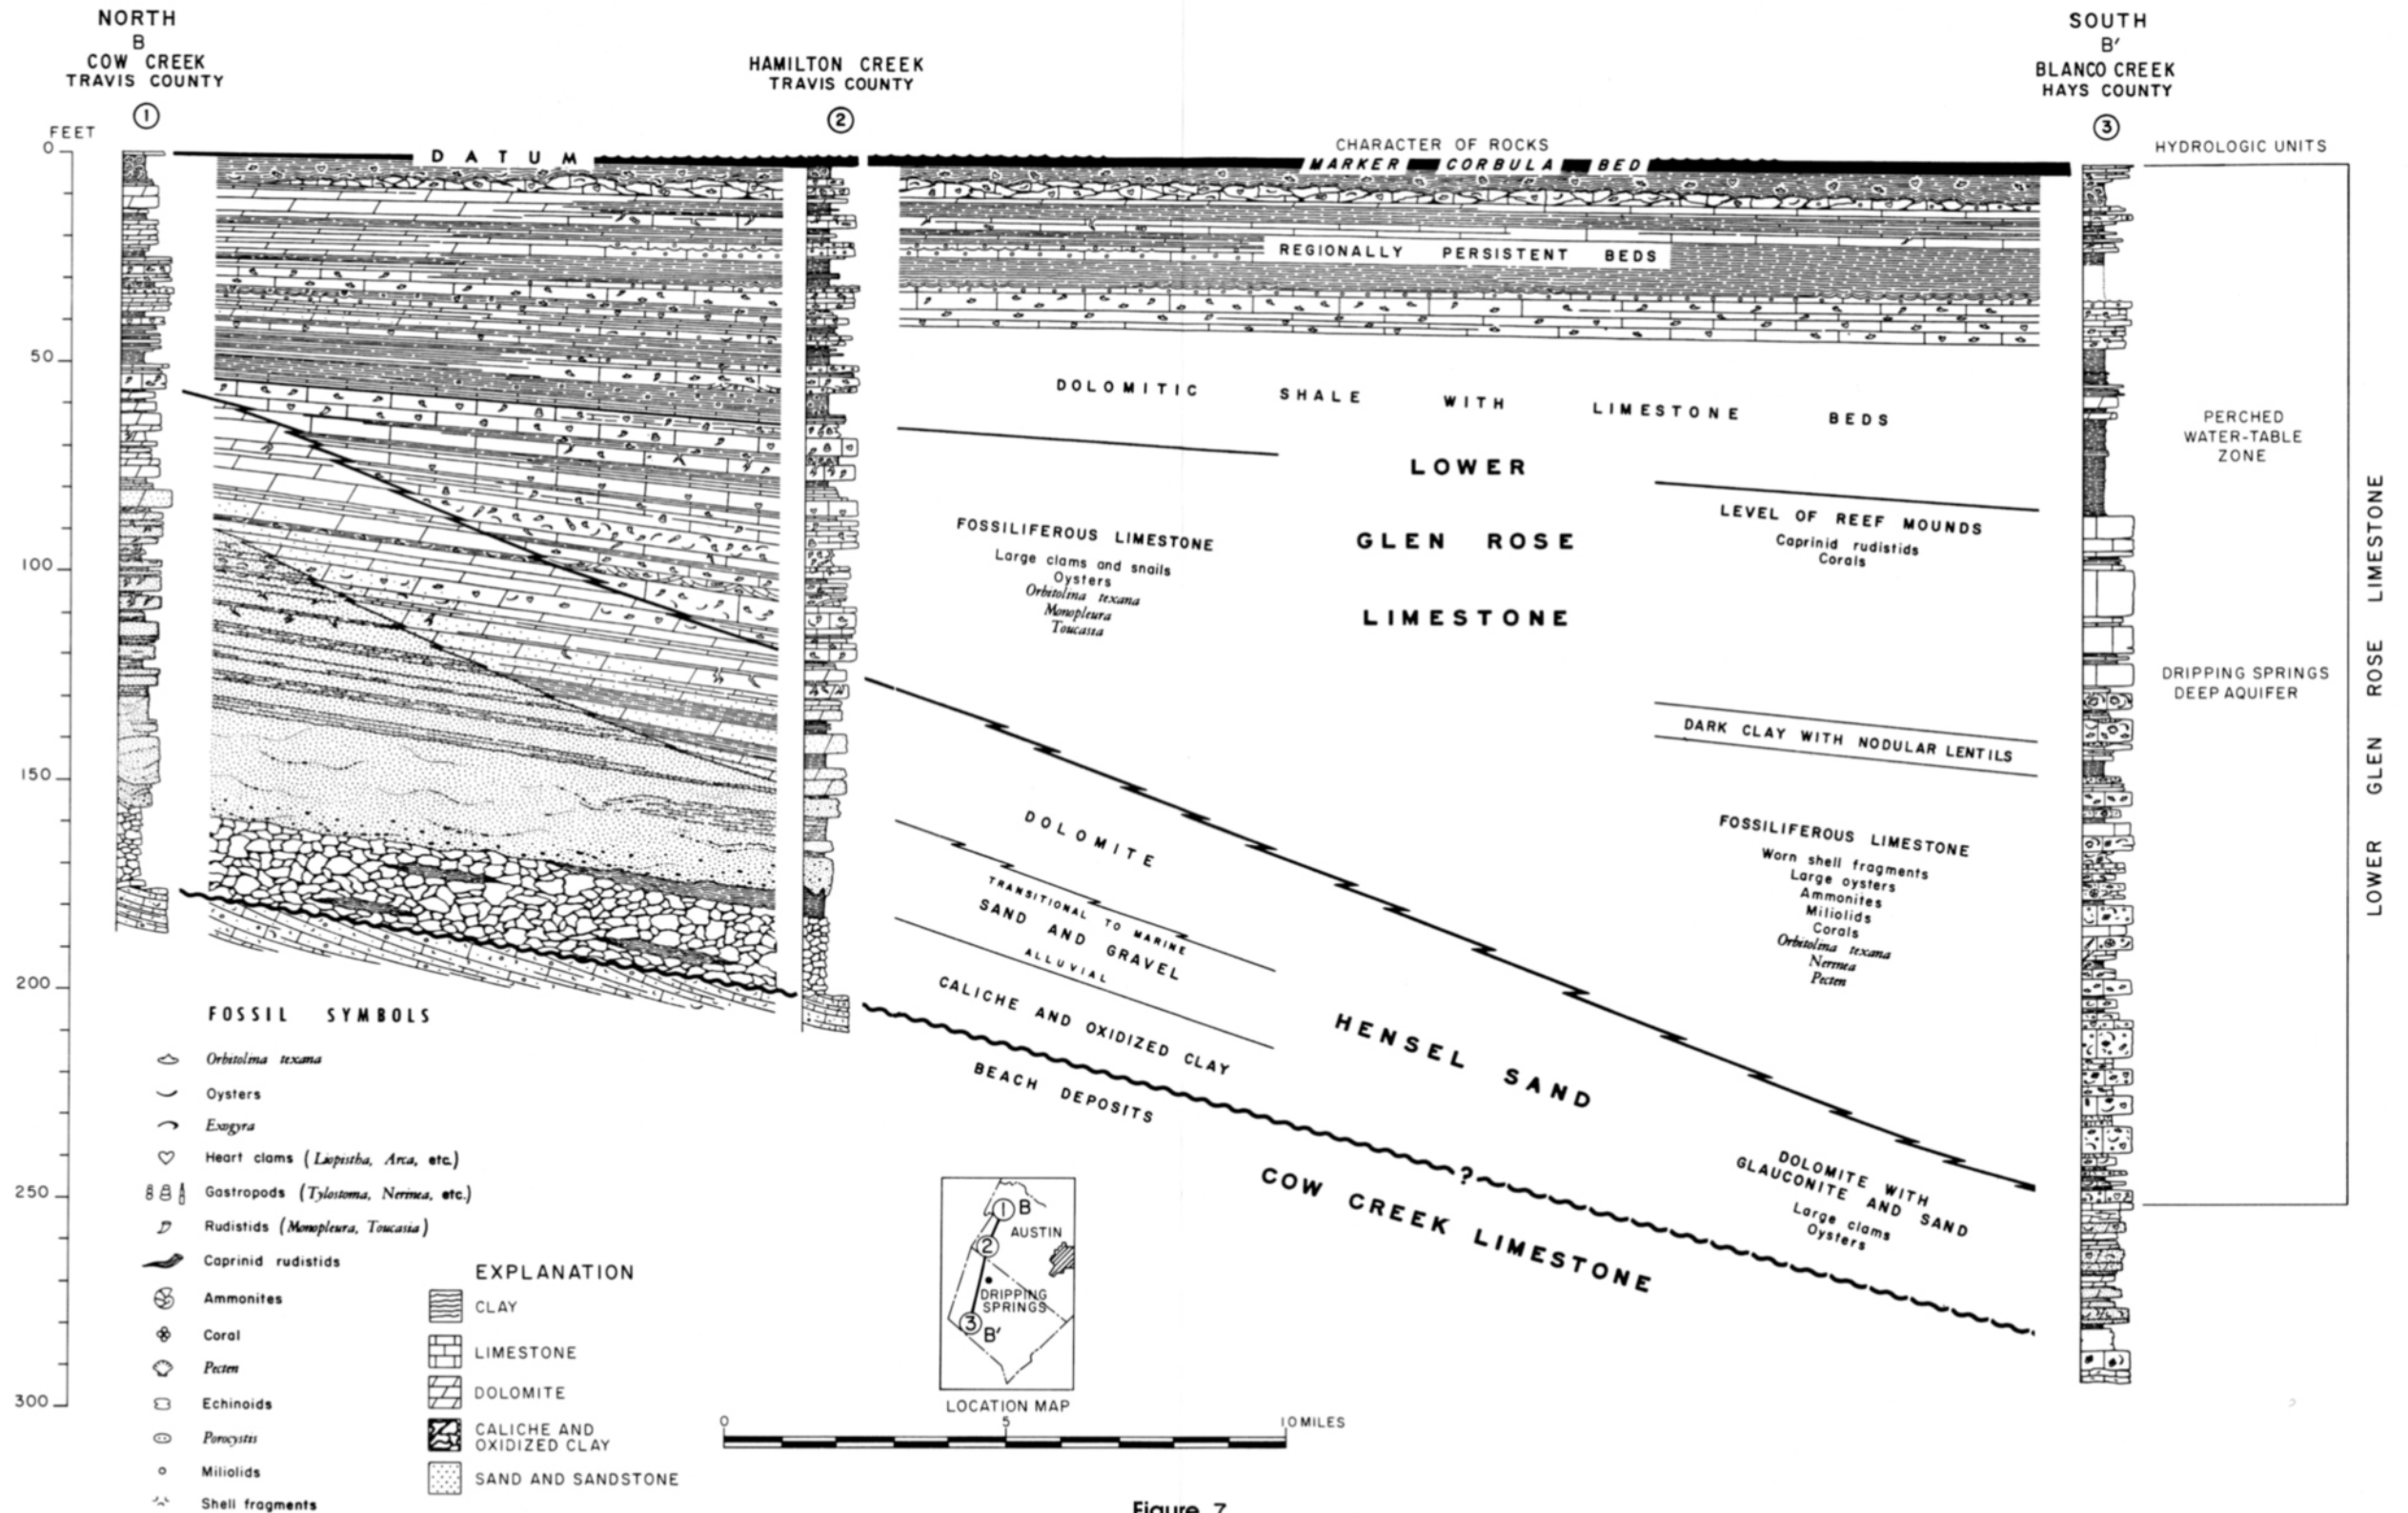
(Modified after Stricklin, Smith, and Lozo, 1971)
